Summer 2022 House Projects
for
The Livingston County Historical Society

Dale C. Maley

September 2022

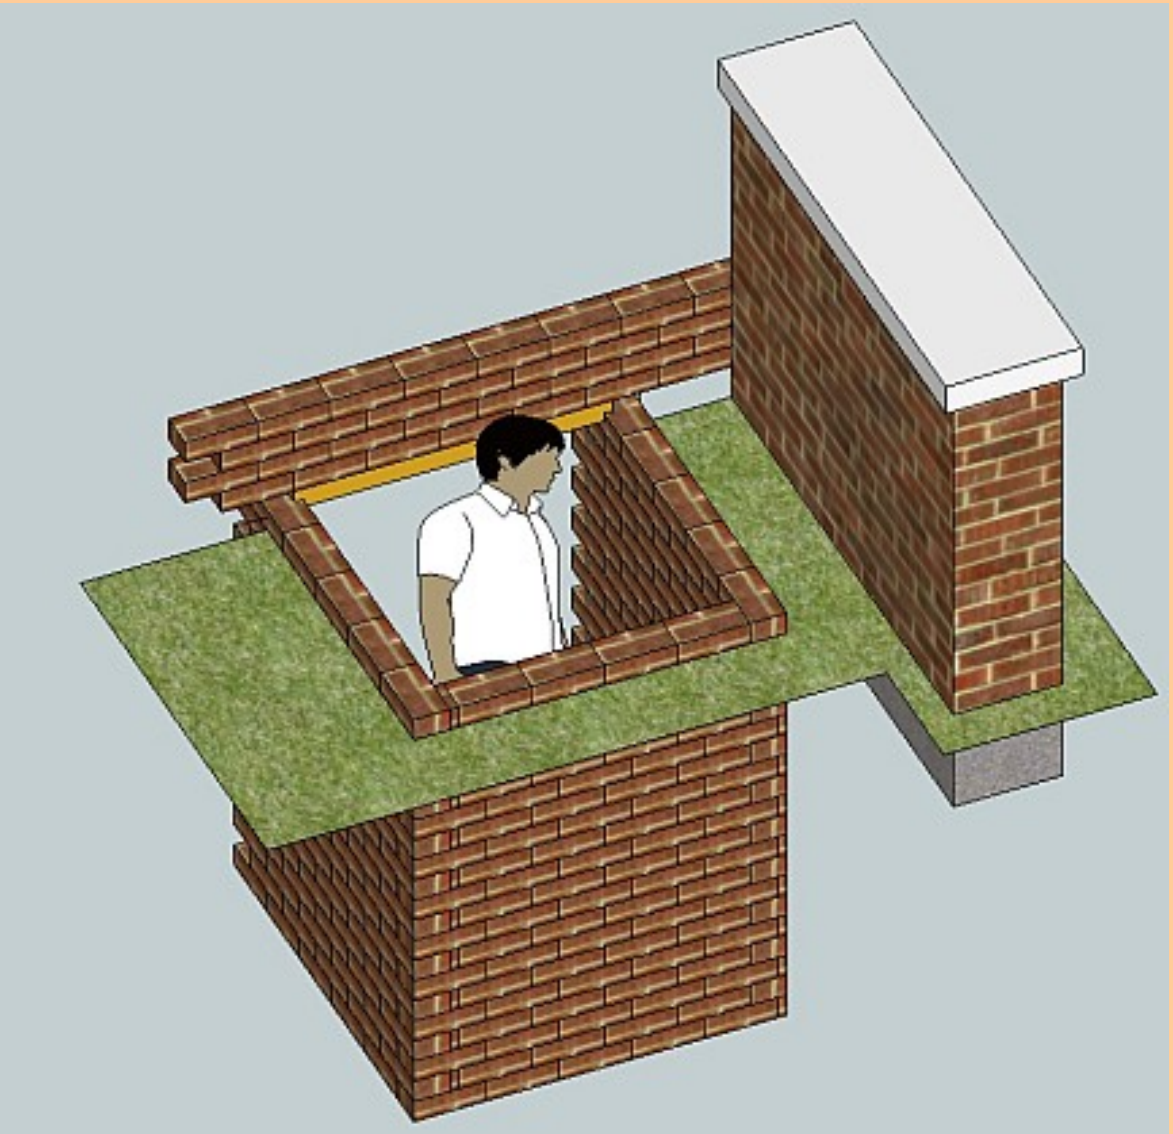
Jones House

- Exterior coal chute added maybe 1870?
- Brick wall around backyard added circa 1978
- 2,000 Lb. brick wall within 10” of a 5 ft. deep hole
- Pushed in north brick lined wall
- Note board support

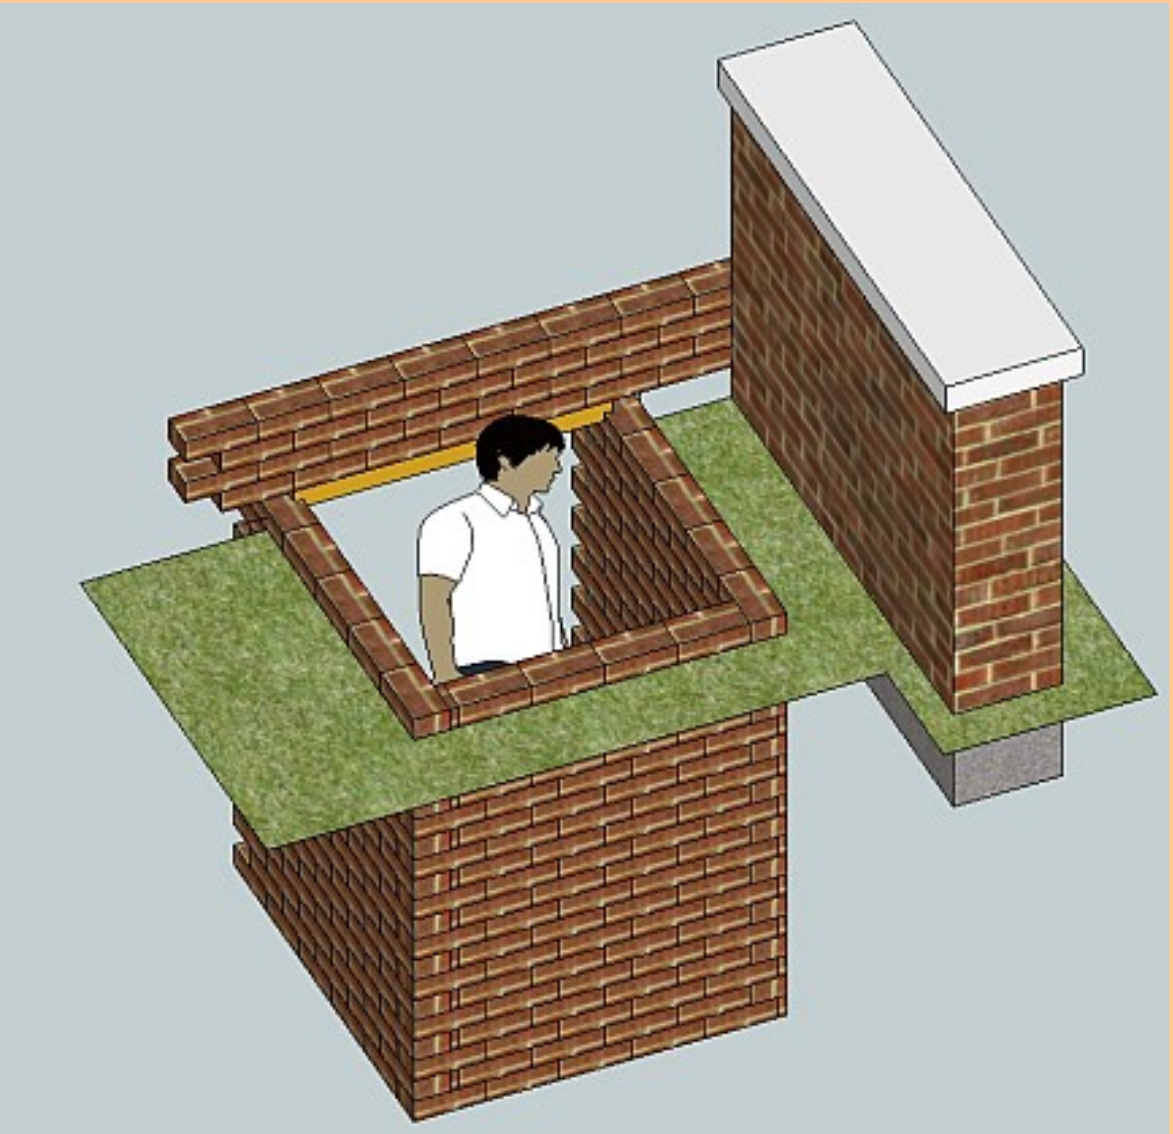
Jones House

•Story to wife….

“No safety issues with this project….

If I’m in the hole and wall blows out….

2,000 Lb brick wall falls on me first….

Then the whole brick corner of house ☺

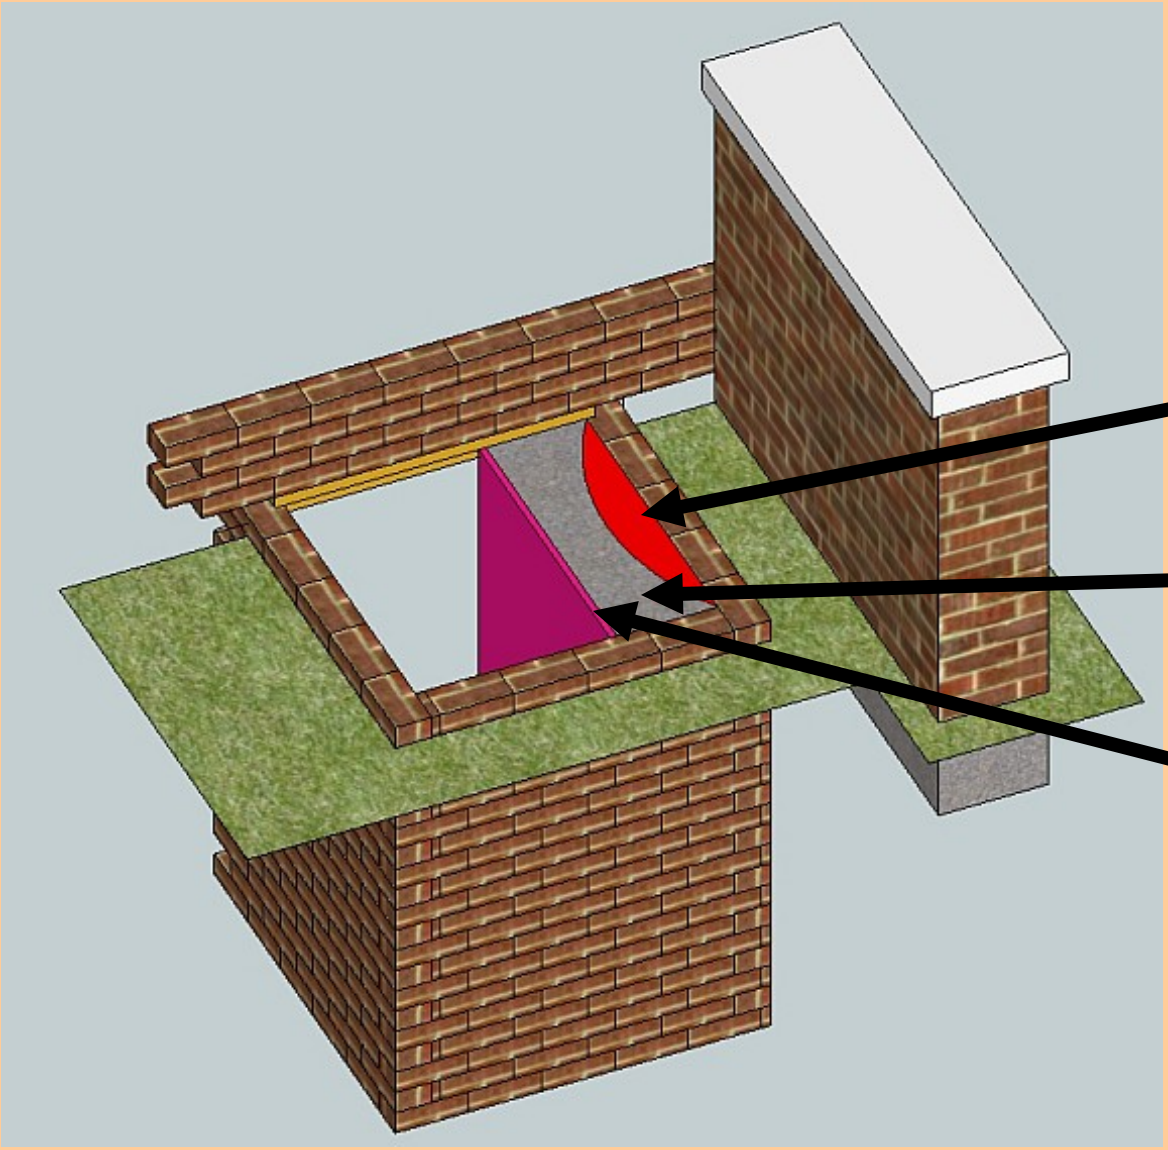
Jones House

Brick wall bulge
New concrete wall
Plywood form, do not touch bulging wall!

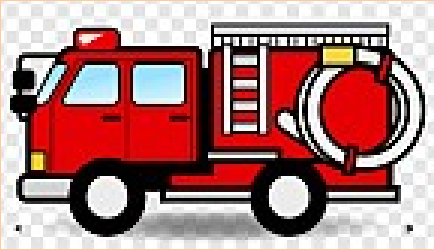
Jones House

Tell “Ambulance & Fire Truck story”

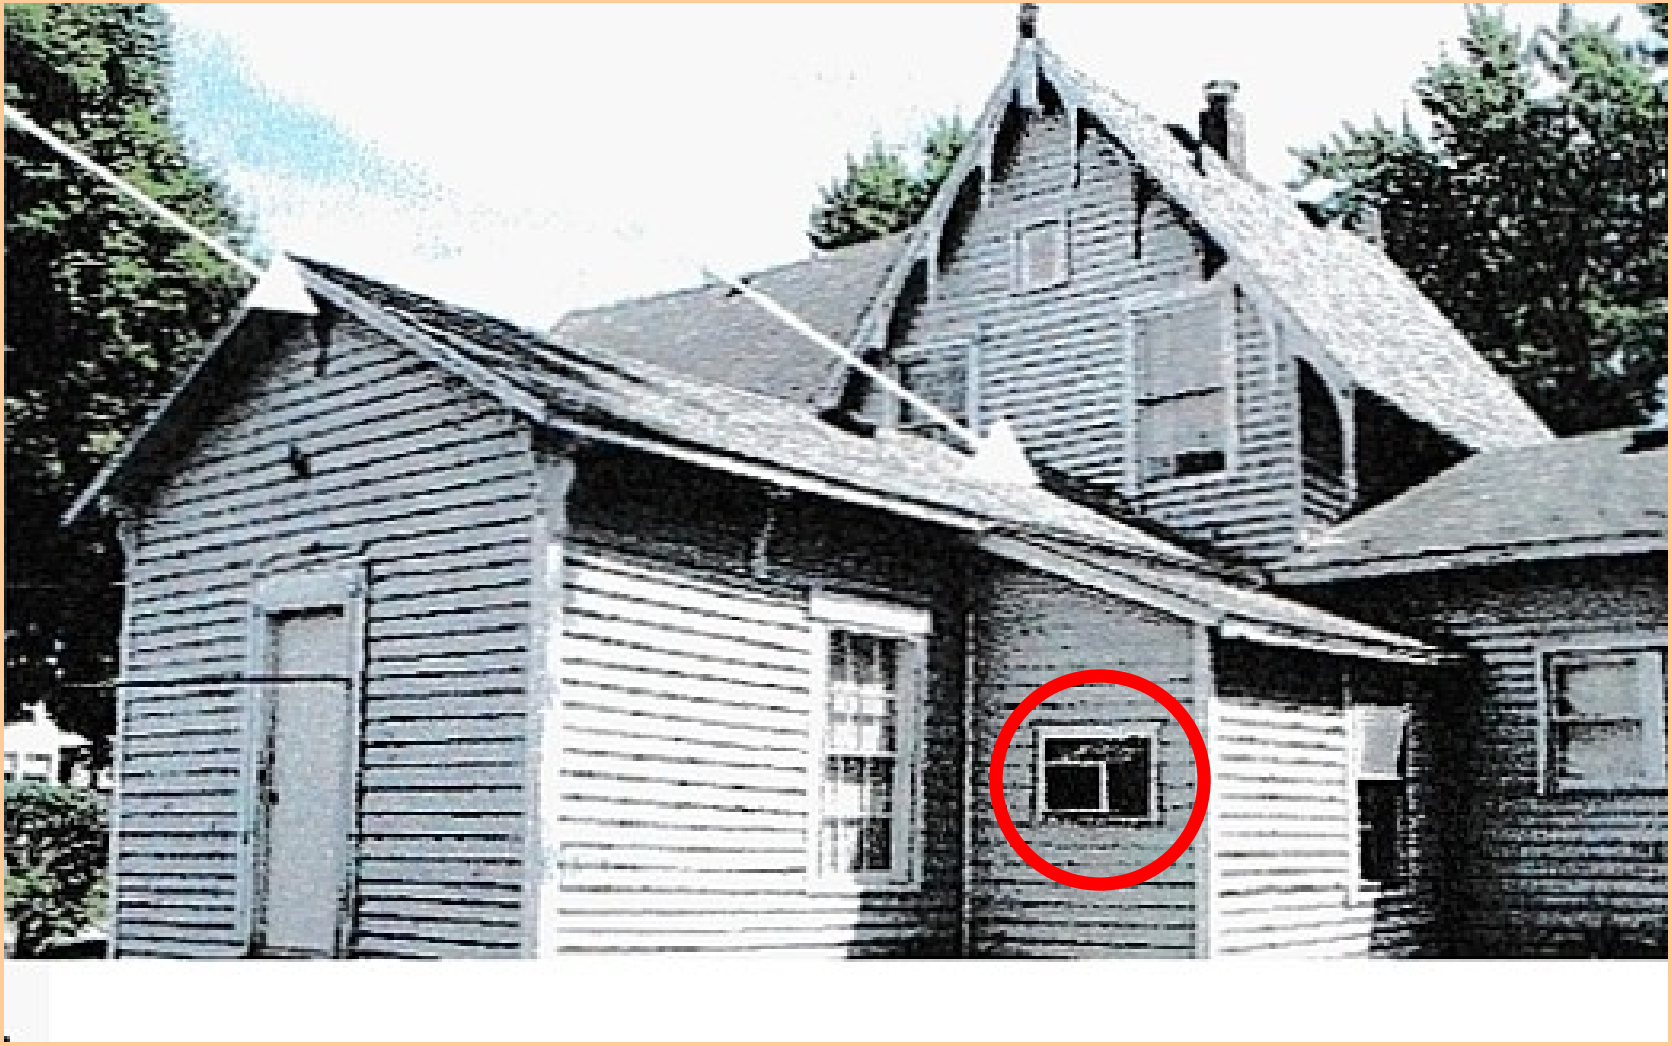
Strevell House Window Repair

Window AC Unit in small room before renovation started

- Window was dry-walled over in new restroom (Inside)
- Exterior window frame not removed and piece of OSB board nailed over window opening
- I caulked and painted in summer of 2021
- Need new cedar siding to fill opening
- Fairbury lumberyard story
  $2,000 minimum order ☹
- Special order Menards for $112
